**Tree Inventory and Preservation Plan  
2451 – 2495 Danforth Avenue  
Toronto, Ontario**

18 June 2024; revised 5 November 2024 and 8 September 2025

KUNTZ FORESTRY CONSULTING INC. Project P3422

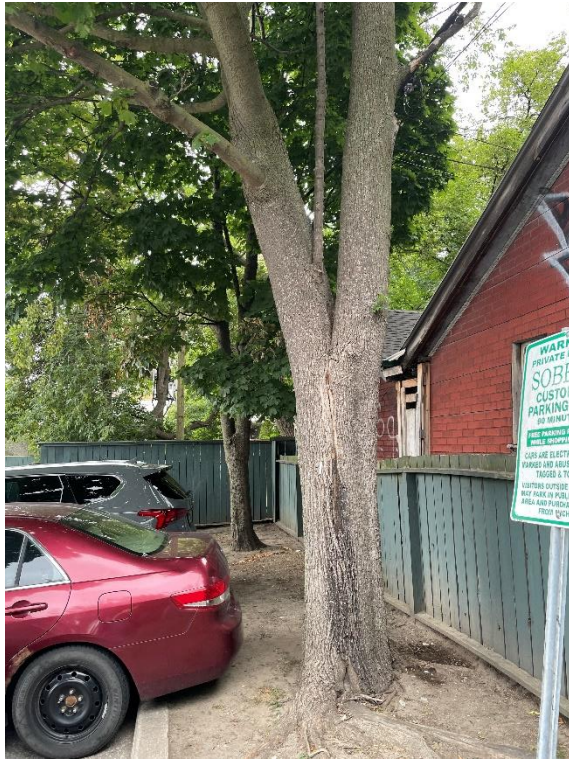
Image 1. Trees 55 (far) and 56 (near)

Encroachment into the mTPZs of Trees 55, 56, E, and F will be required to accommodate the removal of the existing surface parking area. Tree preservation fencing has been prescribed at the anticipated limits of encroachment within the mTPZs of these trees. It is anticipated that very few roots, if any, extend beneath the existing surface parking area. If the following mitigation measures are employed, long-term adverse effects are not anticipated for these trees.

| Tree # | Common Name | Scientific Name | DBH | TI | CS | CV | CDB | Cat. | mTPZ | Comments | Action |
|---|---|---|---|---|---|---|---|---|---|---|---|
| 55 | Norway Maple | <i>Acer platanoides</i> | 36 | PF | PF | PF | | 1 | 2.4 | V-union at 2m (codominance) with included bark, stem wounds (M) with decay (L), poor form (L), one leader lost at 5m, decay (L) in trunk | Preserve (Injure) |
| 56 | Norway Maple | <i>Acer platanoides</i> | 59.5 | PF | F | F | | 1 | 3.6 | V-union at 2.5m (codominance) with included bark, growth deficit (M), exposed roots (M) with wounds (M), cavities (M), seam (M) from 1m to 2.5m | Preserve (Injure) |

1. Prior to the commencement of the proposed works, tree preservation fencing should be installed as show on Figure 1.
2. The existing surface parking area within the mTPZs of these trees should be removed carefully using small machinery (i.e. a skidsteer or miniature excavator) and under the supervision of a Certified Arborist.

3. Any roots encountered within the subsurface material are to be left intact.
4. Once the existing hardscape has been removed, no machinery use will be permitted within the exposed mTPZ area from which the hardscape was removed.

5. Any softscaping required within the mTPZs of these trees should occur by hand during the final landscaping stage.
6. All works to occur within the mTPZs of these trees should be supervised by a Certified Arborist in accordance with Good Arboricultural Standards.

7. Branches that extend into the proposed development and require pruning must be pruned by a Certified Arborist or other tree professional in accordance with Good Arboricultural Standards.

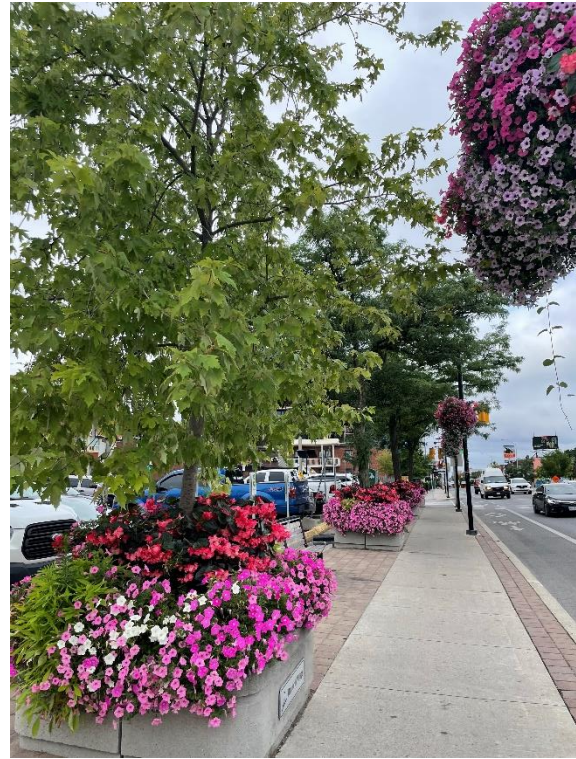
Image 2. From Tree 60 (front, left), facing west

| Tree # | Common Name | Scientific Name | DBH | TI | CS | CV | CDB | Cat. | mTPZ | Comments | Action |
|---|---|---|---|---|---|---|---|---|---|---|---|
| 60 | Freeman Maple | <i>Acer x freemanii</i> | 11 | FG | G | G | | 5 | 1.8 | Lean (L), in raised planter, stem wounds (L) | Remove |

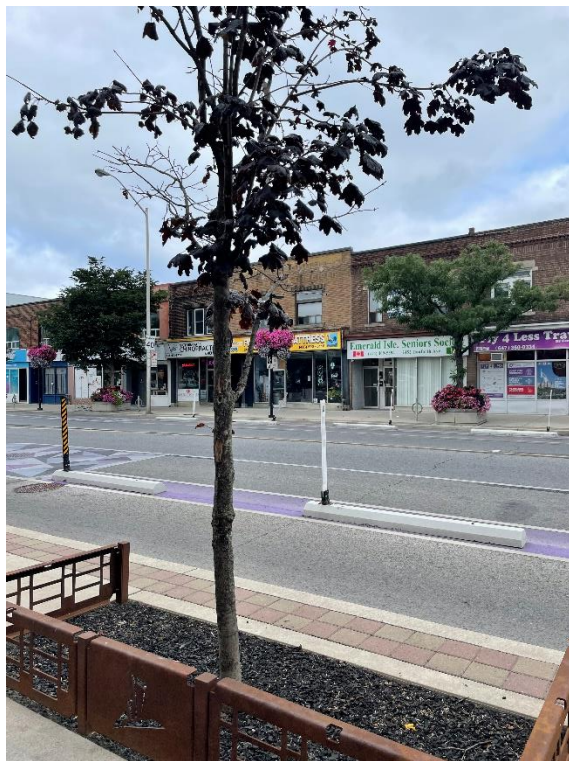
Image 3. Tree 61

The removal of five additional dead trees is recommended due to their condition, regardless of the proposed development. The trees identified for removal due to their condition include Trees 61, 64, 66, 67, and B.

| Tree # | Common Name | Scientific Name | DBH | TI | CS | CV | CDB | Cat. | mTPZ | Comments | Action |
|---|---|---|---|---|---|---|---|---|---|---|---|
| 61 | Norway Maple | <i>Acer platanoides</i> | 8.5 | D | D | D | 100 | 5 | - | | Remove (Condition) |

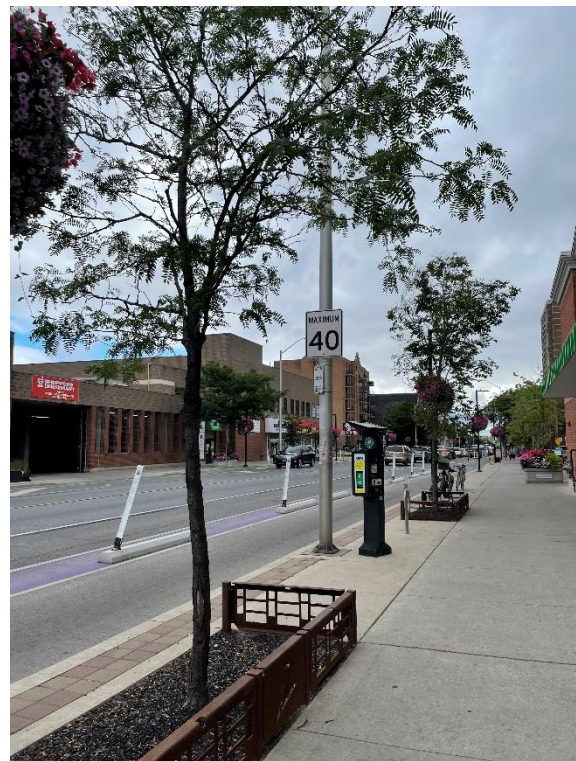
Image 4. Trees 62 (near) and 63 (far)

| Tree # | Common Name | Scientific Name | DBH | TI | CS | CV | CDB | Cat. | mTPZ | Comments | Action |
|---|---|---|---|---|---|---|---|---|---|---|---|
| 62 | Shademaster Honey Locust | <i>Gleditsia triacanthos 'inermis'</i> | 10 | F | FG | F | 10 | 5 | 1.8 | Stem wounds (L) with decay (L), deadwood (L), bow (L), epicormic branching (L) | Remove |
| 63 | Elm cultivar | <i>Ulmus x</i> | 13 | F | F | FG | | 5 | 1.8 | Stem wounds (L) with decay (L), girdling roots (L) | Remove |

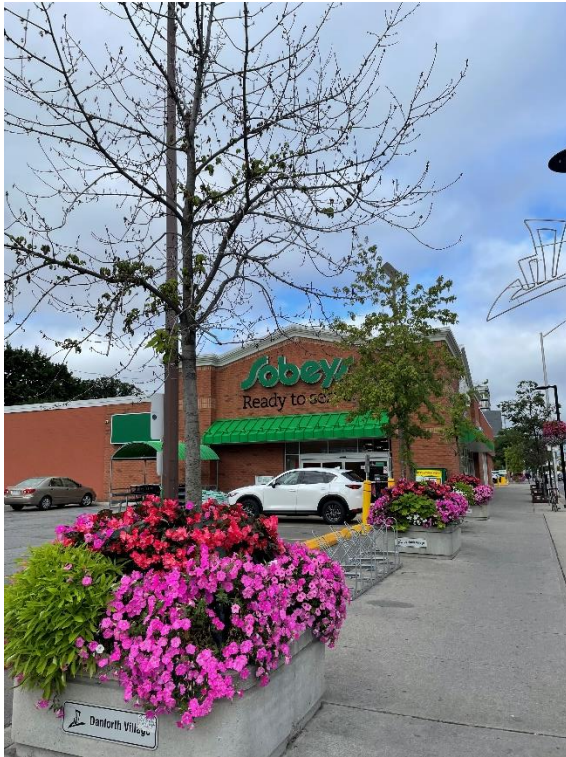
Image 5. From Tree 66 (front, left), facing west

| Tree # | Common Name | Scientific Name | DBH | TI | CS | CV | CDB | Cat. | mTPZ | Comments | Action |
|---|---|---|---|---|---|---|---|---|---|---|---|
| 66 | Freeman Maple | <i>Acer x freemanii</i> | 10 | D | D | D | 100 | 5 | - | In raised planter | Remove (Condition) |

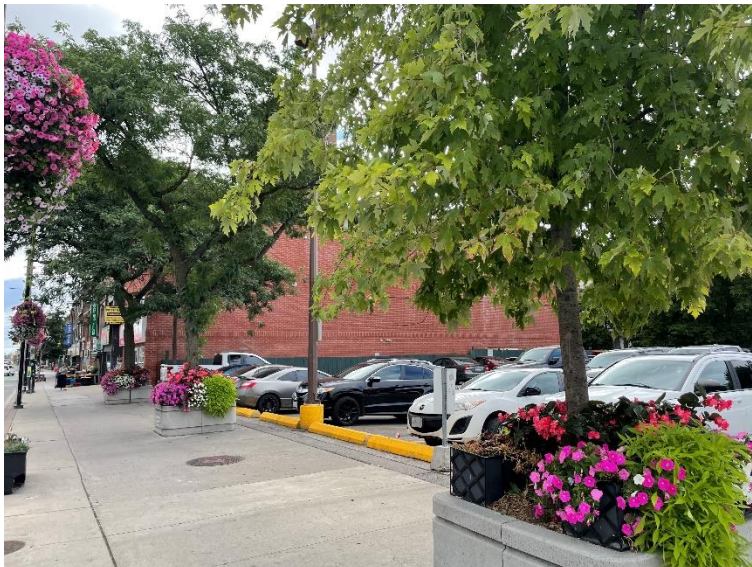
Image 6. From near to far, Trees 67 – 69

| Tree # | Common Name | Scientific Name | DBH | TI | CS | CV | CDB | Cat. | mTPZ | Comments | Action |
|---|---|---|---|---|---|---|---|---|---|---|---|
| 67 | Freeman Maple | <i>Acer x freemanii</i> | 12.5 | D | D | D | 100 | 5 | - | In raised planter | Remove (Condition) |
| 68 | Shademaster Honey Locust | <i>Gleditsia triacanthos 'inermis'</i> | 30 | FG | F | F | 10 | 5 | 2.4 | Epicormic branching (M), in raised planter, bow (L) | Remove |
| 69 | Shademaster Honey Locust | <i>Gleditsia triacanthos 'inermis'</i> | 36 | G | G | G | | 5 | 2.4 | In raised planter | Remove |

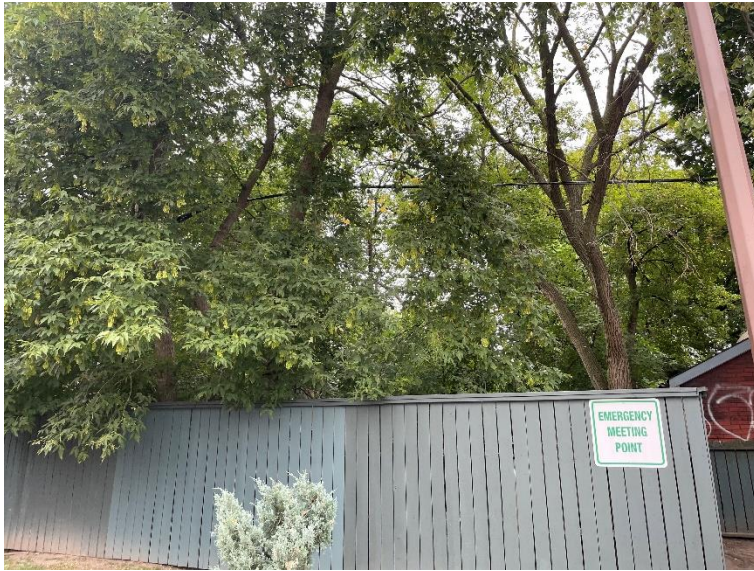
Image 7. Trees A (left) and B (right)

Encroachment into the mTPZ of Tree A will be required to accommodate the installation of proposed retaining wall. Tree preservation fencing has been prescribed at the anticipated limit of encroachment within the mTPZ of this tree. If the following mitigation measures are employed, long-term adverse effects are not anticipated for this tree.

| Tree # | Common Name | Scientific Name | DBH | TI | CS | CV | CDB | Cat. | mTPZ | Comments | Action |
|---|---|---|---|---|---|---|---|---|---|---|---|
| A | Manitoba Maple | <i>Acer negundo</i> | ~36, 36, 34, 30, 15 | PF | PF | F | 10 | 2 | 2.4 | V-union at 1m with included bark, epicormic branching (M), union at base, one leader cut at 3m, bow (L-H) | Preserve (Injure) |
| B | White Elm | <i>Ulmus americana</i> | ~48 | D | D | D | 100 | 2 | - | | Remove (Condition) |

1. Prior to the commencement of the proposed works, tree preservation fencing should be installed as show on Figure 1.
2. Air-spade or low-pressure hydro-vacuum technology should be used to excavate a trench at the anticipated limit of excavation within the mTPZ of this tree, under the supervision of a Certified Arborist.

3. The depth of the trench will depend on the depth of excavation required to install the proposed retaining wall, to a maximum of 90cm or as conditions dictate.

4. Any roots exposed within the trench that require pruning should be pruned by a Certified Arborist in accordance with Good Arboricultural Standards.
5. The trench is to be backfilled with clean topsoil.

6. Any softscaping required within the mTPZ of this tree should occur by hand during the final landscaping stage.
7. All works to occur within the mTPZ of this tree should be supervised by a Certified Arborist in accordance with Good Arboricultural Standards.

8. Branches that extend into the proposed development and require pruning must be pruned by a Certified Arborist or other tree professional in accordance with Good Arboricultural Standards.

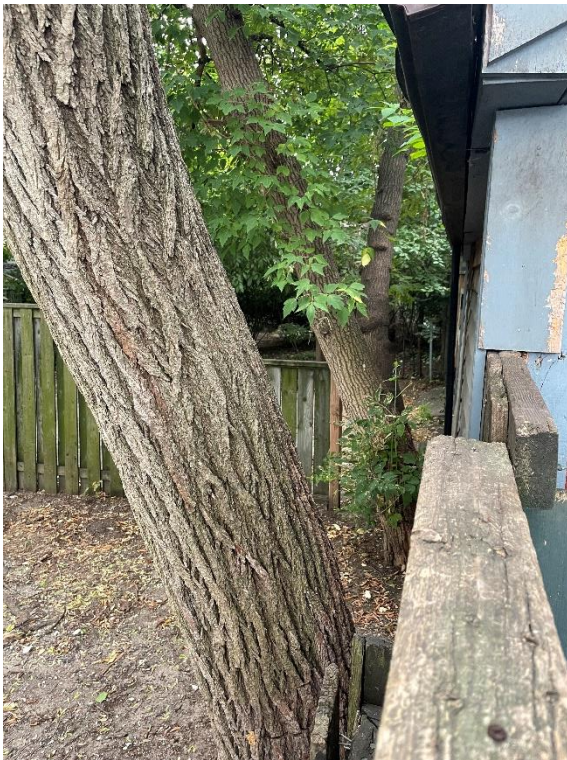
Image 8. Trees B (near) and C (far)

| Tree # | Common Name | Scientific Name | DBH | TI | CS | CV | CDB | Cat. | mTPZ | Comments | Action |
|---|---|---|---|---|---|---|---|---|---|---|---|
| C | Manitoba Maple | <i>Acer negundo</i> | ~34, 28 | PF | PF | PF | 20 | 2 | 2.4 | V-union at 0.5m with included bark, epicormic branching (M), lean (M), cavities (L), deadwood (L), poor form (M) | Preserve |

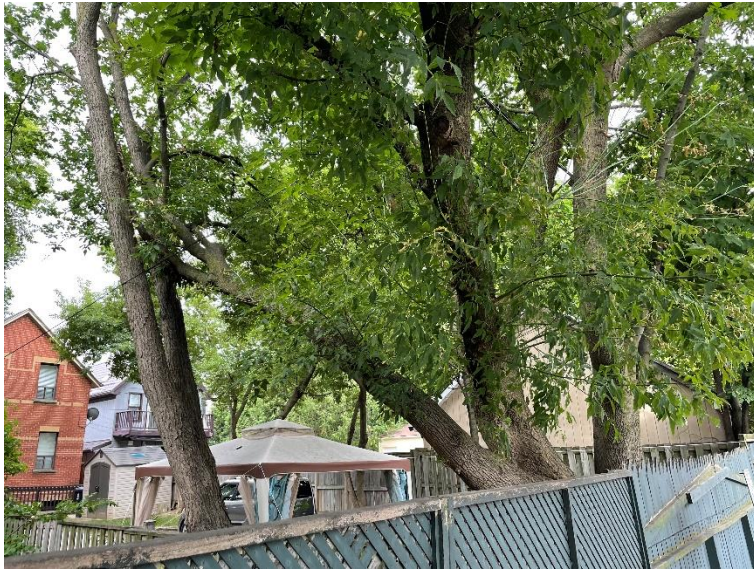
Image 9. From left to right, Trees D – F

| Tree # | Common Name | Scientific Name | DBH | TI | CS | CV | CDB | Cat. | mTPZ | Comments | Action |
|---|---|---|---|---|---|---|---|---|---|---|---|
| D | White Elm | <i>Ulmus americana</i> | ~50 | F | FG | FG | | 2 | 3.0 | Bow (L), v-union at 1.5m with included bark | Preserve |
| E | Manitoba Maple | <i>Acer negundo</i> | ~52 | PF | PF | F | 10 | 1 / 2 | 3.6 | V-union at 2m with included bark, cavities (L), epicormic branching (M), multiple branch attachments, poor branch unions, branches fused to branches of Tree F, appears to be located mostly on neighbouring property but likely shared | Preserve (Injure) |
| F | Norway Maple | <i>Acer platanoides</i> | ~42 | F | F | F | | 1 / 2 | 3.0 | Branches fused to branches of Tree E, union at 2.5m, asymmetrical crown (M), multiple branch attachments, appears to be located mostly on neighbouring property but likely shared | Preserve (Injure) |

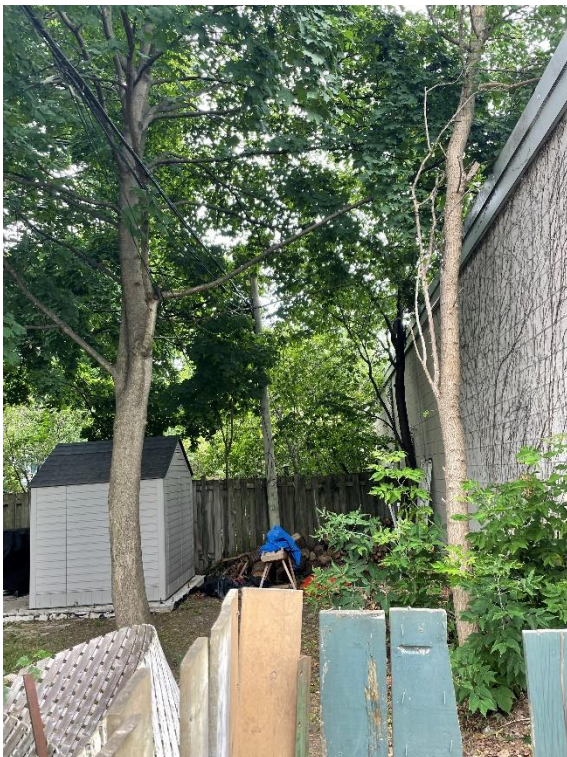
Image 10. Trees I (front, right), J (back, right), and K (front, left)

| I | White Mulberry | <i>Morus alba</i> | ~16 | FG | PF | PF | 30 | - | 1.8 | Deadwood (M), bow (L), narrow crown, epicormic branching (M) | Remove |
| J | Scotch Elm | <i>Ulmus glabra</i> | ~18 | G | G | G | | - | 1.8 | | Remove |
| K | Norway Maple | <i>Acer platanoides</i> | ~28 | FG | G | FG | | - | 1.8 | Sweep (L) | Preserve |

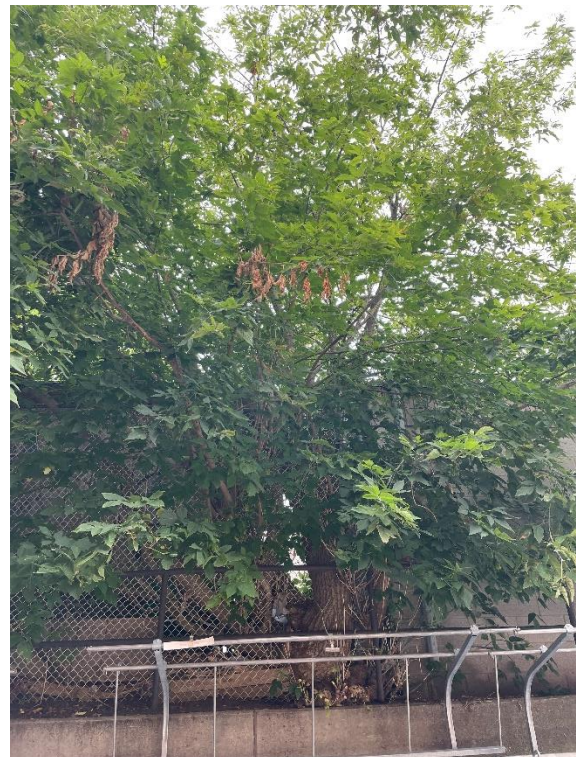
Image 11. Tree L

It should be noted that Tree L is located atop an approximately 1.5m high retaining wall. The roots of Tree L are not expected to extend into the subject site, and as such, the preservation of this tree will be possible. Tree preservation fencing has not been prescribed for this tree.

| L | Manitoba Maple | <i>Acer negundo</i> | ~44, 42,<br>15, 10 | P | P | PF | 20 | 1/2 | 3.0 | Included fence (H), v-union at 0.2m with included bark, larger stems pruned at 2.5m, epicormic branching (H), pruning wounds (H), poor form (H), lean (L-M), appears to be located mostly on subject site but likely shared, at top of retaining wall | Preserve |

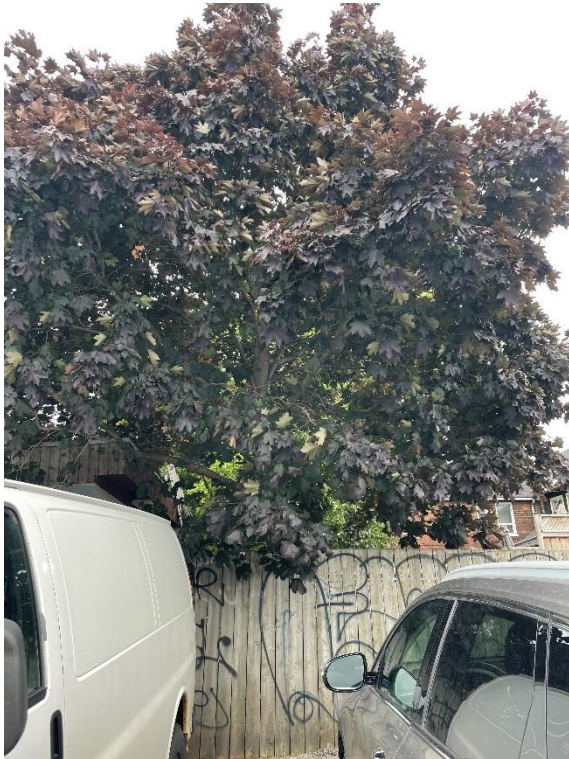
Image 12. Tree M

| M | Norway Maple | <i>Acer platanoides</i> | ~28 | F | G | FG | | | 1.8 | Lean (M) | Remove |
